Description

The 6116N 2.5kg grease kit is a manually operated, spring powered grease kit that comes complete with a hand piece. It is designed to fit a 2.5kg grease pail. The hand piece for the 6116N, once loaded, is capable of approximately 30 high pressure shots before needing to be reprimed. The high pressure/high volume option facilitates quick and easy greasing with grease pressures of 10,000psi and dispensing quantities of up to 1.25 grams per stroke possible. Suitable for use with greases up to NLGI2, the light weight, rugged and portable unit makes light work of arduous greasing applications. The 6116N/6116 is the ideal greasing tool for people looking to minimize the time and effort required to grease their vehicles or machinery.

Parts and Drawing Breakdown For The Pump Kit Of The 6116N

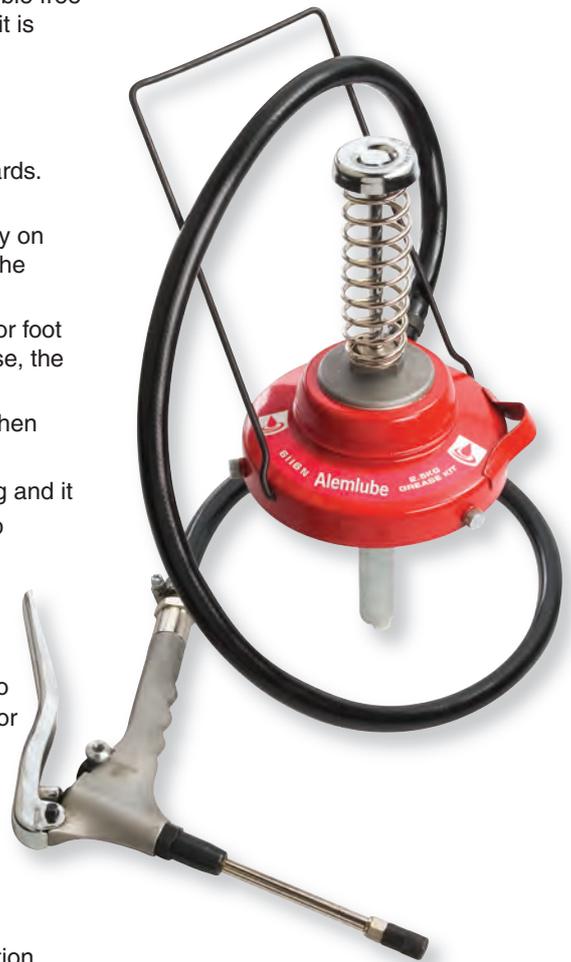
Should the strainer need cleaning, (refer trouble shooting guide, page 3, item C(b)),undo the nut at the base of the pump spring with a suitable spanner, remove assembly, lever off strainer cover and clean the appropriate parts as illustrated.

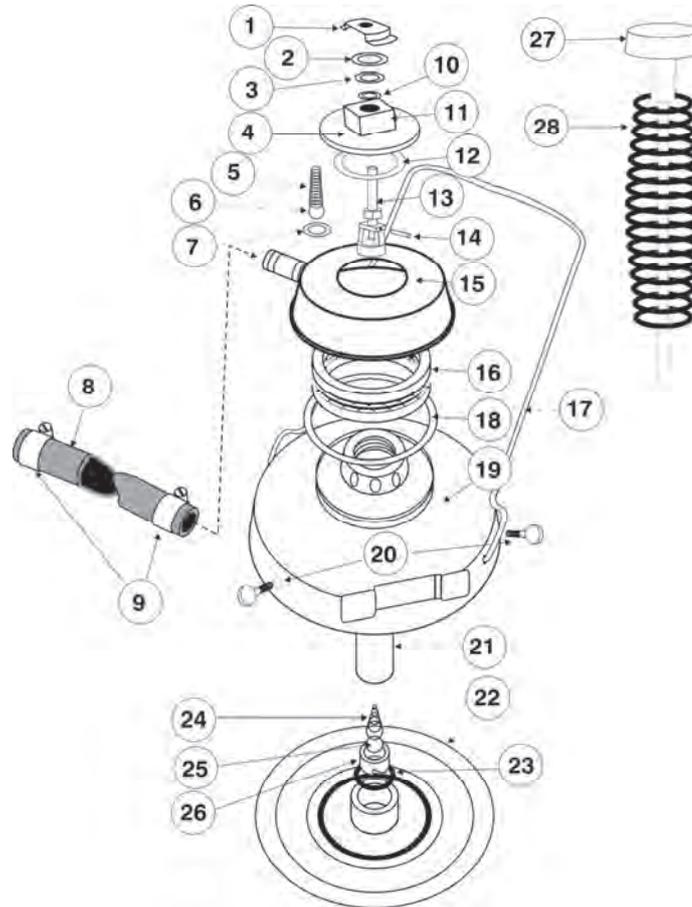
ITEM	PART NUMBER	DESCRIPTION
1	6116-1	Retainer Cap
2	6116-2	Washer
3	6116-3	Back up washer
4	6116-4	Clamp nut
5	6116-5	Ball spring
6	6116-6	1/2" Ball
7	6116-7	O'Ring
8	6116-8	Hose
9	6116-9	Hose Clamp
10	6116-10	O'Ring
11	6116-11	Clamp Nut
12	6116-12	Sealing Washer
13	6116-13	Piston Rod and Cup Assembly
14	6116-14	Spirol Pin
15	6116-15	Strainer Cover
16	6116-16	Strainer
17	6116-17	Handle
18	6116-18	O'Ring
19	6116-19	Lid Base
20	6116-20	Thump Screw
21	6116-21	Pump Tube
22	6116-22	Follower
23	6116-23	O'Ring
24	6116-24	Ball Retainer
25	6116-25	9/16" Ball
26	6116-26	Footvalve
27	6116-27	Piston Rod and Cap Assembly
28	6116-28	Pump Spring

PROBLEM	CAUSE	SOLUTION
Rod cap rises slowly when the hand piece is not in use (no visible external leakages)	(a) dirt trapped between inlet ball (26) and piston (b) piston O'Ring (25) defective or worn	(a) unscrew clamp nut (7) and withdraw assembly. Clean ball (26) and piston (10) thoroughly. Reassemble (b) replace piston O'Ring order (6116-6)
Rod cap springs up and the unit will not pump grease	(a) air lock in grease caused by dent in container stops follower damaged O'Ring (21) in follower (20) (b) grease container empty (c) footvalve assy (19) faulty, holding ball (18) off seat	(a) remove dents or tilt follower plate (20) under dent. Replace O'Ring (21) in follower plate (20). Change over to new container or refill with grease. Replace with new assy 6116-17-18-19 do not attempt to rework this part.
Rod cap stays down. The 2.5kg grease kit will not pump grease	(a) grade of grease too heavy (b) strainer blocked	(a) Use No. 2 grade of grease, or lighter. Force out old grease. (b) Unscrew clamp nut (7) and withdraw assembly. Using a screwdriver, lever off the strainer cover (11). Clean or replace the strainer (13). see general instructions below for cleaning technique.

Grease leaks at top of clamp nut (7)	Gland O'Ring (96) and back up washer (5) are defective or worn	Unscrew clamp nut (7) and withdraw assembly. Hold piston (10) and loosen the nut (27). Remove the pin (9) and withdraw the piston (10). Ease spring tension on the nut (27) by pushing against spring (92) on clamp nut (7) and carefully undo nut (27). Replace O'Ring (96) and back up washer (5). Order (6116-5). When re-assembling support piston (10) when driving pin (9) home, please ensure that the flat end of spring (2) fits in the cap (1).
Grease leaks at bottom of strainer cover (11)	(a) O'Ring (14) damaged (b) Spot welds broken	(a) Unscrew clamp nut (7) and withdraw assembly. Using screwdriver, lever off strainer cover (11) replace O'Ring Order (6116-14) (b) Replace drum cover base (15).
Grease leaks from under clamp nut (7)	(a) Dirt under clamp nut (7) (b) Damaged seal washer (8)	(a) Undo and clean surfaces (b) Replace seal washer. Order (6116-8).

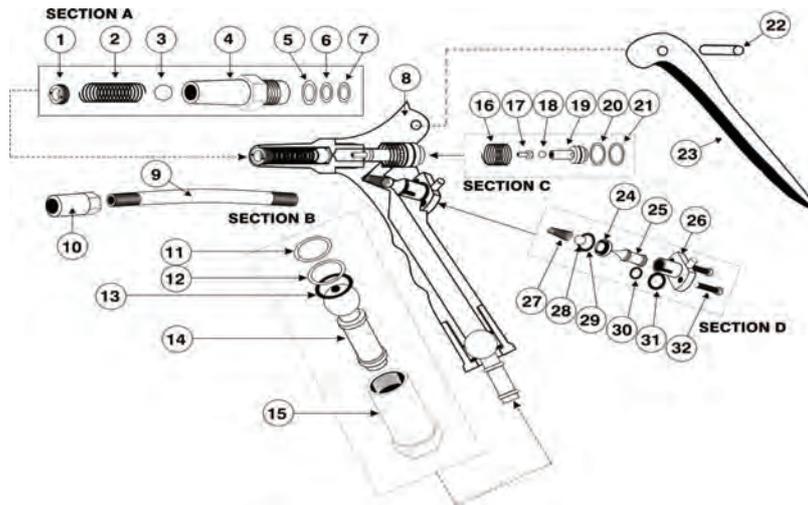
Parts and Drawing Breakdown For The 6116N Hand Piece

ITEM	PART NUMBER	DESCRIPTION	QUANTITY
1	6116HP-1	Outlet Screw	1
2	6116HP-2	Outlet Spring	1
3	6116HP-3	Outlet Ball	1
4	6116HP-4	Outlet Body	1
5	6116HP-5	Teflon Back Up Washer	1
6	6116HP-6	Glyd Ring	1
7	6116HP-7	Piston O'Ring	1
8	6116HP-8	Hand Piece Casting	1
9	6116HP-9	Rigid Extension	1
10	14513	Grease Coupler	1
11	6116HP-11	Retainer O'Ring	1
12	6116HP-12	Hose Adaptor Washer	1
13	6116HP-13	Hose Adaptor O'Ring	1
14	6116HP-14	Hose Adaptor Ball End	1
15	6116HP-15	Ball Socket Retainer	1
16	6116HP-16	Inlet Check Spring	1
17	6116HP-17	Valve Stem Piston	1
18	6116HP-18	Piston Ball	1
19	6116HP-19	Piston	1
20	6116HP-20	Glyd Ring	1
21	6116HP-21	Seal Body O'Ring	1
22	6116HP-22	Handle Pin	1
23	6116HP-23	Handle	1
24	6116HP-24	Valve Inlet Seat	1
25	6116HP-25	Operating Plunger Control	1
26	6116HP-26	Control Body Assembly	1
27	6116HP-27	Inlet Spring	1
28	6116HP-28	Inlet Ball	1
29	6116HP-29	Seal Body O'Ring	1
30	6116HP-30	Plunger Control O'Ring	1

31	6116HP-31	Seal Body O'Ring	1
32	6116HP-32	Cap Socket	2

PROBLEM	CAUSE	SOLUTION
The 2.5kg grease kit coupler leaks	<p>(a) There is dirt under the seat of the outer ball (3)</p> <p>(b) The valve stem (17), has worked itself loose and is holding the outlet ball (3), off its seat.</p>	<p>(a) Set the hand piece to the high volume setting and strike handle sharply. If the coupler still leaks, remove the rigid extension (9), spring keeper screw (21), spring (22) and outer ball (23). Clear the seat and partly replace the ball, screw and spring keeper screw. Prime the pump completely to ensure the maximum possible supply of grease to the hand piece and tighten up the spring keeper screw until the grease begins to stop leaking. Then tighten the spring keeper in an extra two full turns. Finally, reassemble the rigid extension to the hand piece. IMPORTANT: Please note that if you tighten up the spring keeper screw too much, the hand piece will become difficult to operate. Too few turns will allow the hand piece to leak. If the coupler still leaks, replace the outlet body (4). When refitting the outlet body to the handle, ensure that the handle is held in the closed position. Doing so enables the back up washers (5 & 7) and o’ring seals to seat squarely on to the piston (19).</p> <p>(b) Remove the handle (23) by withdrawing the handle pin (22). Remove the piston (19), retighten the valve stem (17) or replace with spare part, kit number 6336-SPK1.</p>

Hand piece leaks at the back end of the piston	The glyd ring (20) is worn	<p>Remove handle (22) by withdrawing handle pin (22). Remove the piston (19) and replace with the spare part kit part number 6336-SPK5.</p> <p>IMPORTANT: If any signs of wear are visible on the piston, replace with the spare part kit Part Number 6336-SPK4. 6336-SPK5 will also be required to solve this problem.</p>
The hand piece fails to deliver grease when on the high pressure setting	<p>(a) There is dirt under the delivery ball (18) or there is a damaged ball seat in the piston (19)</p> <p>(b) Seals are worn (25), (26) and (27).</p> <p>(c) Valve inlet stem (17) has become loose or dislodged from the piston (19).</p>	<p>(a) Change the setting to “high volume” and hit the handle (23) hard to shift the dirt off the seat. If leaks are still occurring, remove the handle (23) by withdrawing handle pin (22), spring (16) and ball (18). Clean the ball and seat if the problem continues, order and install spare part kit numbers 6336-SPK4 and 6336-SPK5.</p> <p>(b) Use spare part kit number 6336-SPK6 and replace seals in the following order – washer (5), O’ring (6) and washer (7).</p> <p>(c) Refer to the 2.5kg grease kits coupler leaks section to referencing section (b).</p>

PROBLEM	CAUSE	SOLUTION
The hand piece fails to deliver grease when on the high volume setting	(a) There is dirt on the valve inlet seat (24). (b) Operating plunger control (25) sticking in control body assembly (26).	(a) IMPORTANT: This problem will result in a decreased volume of grease being dispensed per shot. Remove control body (26) and tap out valve inlet seat (24), O' Ring (31), ball (30) and spring (27). Clean the ball and seat and replace in the following order – spring, ball, O'Ring, valve seal and control body. (b) Replace the control body assembly (26).
Control push rod in the control body leaks	O' Ring (31) is worn	Remove control body assembly (26) from the hand piece. Also remove the operating control plunger (25) from the control body and replace with spare part kit number 6336-SPK7
Hand piece leaks at the grease swivel	Worn seals (11) & (12)	Unscrew ball socket retainer (15), push the seals out and use spare part kit number 6336-SPK8. Be careful to replace the components in the following order – O'Ring (13) and washer (12). Locate O'Ring (11) on to the hand piece casting (8). Reassemble ball socket retainer on to the hand piece.

When on the high volume setting, the hand piece is too slow and too hard to operate	(a) Spring (16) may have weakened or collapsed and are blocking the flow of grease (b) The grade of grease being used is too heavy. (c) Too much comprehension on the outlet spring (2).	(a) Replace spring (16) and use spare part kit number 6336-SPK5 and valve stem spare part kit number 6336-SPK1. (b) Change to an NLGI2 or lower viscosity grease. (c) Reset the spring keeper screw as noted in the 2.5kg grease kits coupler leaks section. If the problem persists, you will need to replace the outlet body assembly.
