Case Study

Root Cause Analysis

Capping Machine

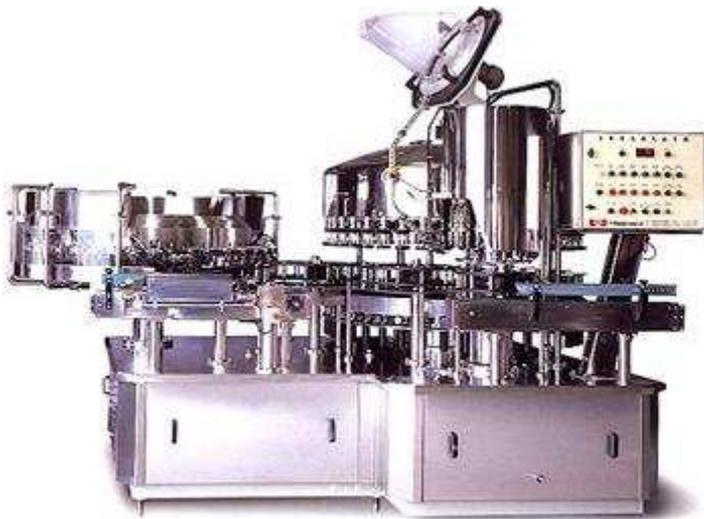
The main capping machine was experiencing extreme belt wear on the capping machine drive. This belt was requiring maintenance weekly to ensure the belt wouldn't fail in use. The client was installing a new belt every two weeks to ensure ongoing machine reliability. The drive belt being used, 10T2000-50, was correct for the machine at time of manufacture. The wear on the pulleys had changed the profile of the pulleys such that the 10T profile was no longer a snug fit. The belt being used was changed to an incorrect type to try and get the machine to work. Extra tension was put on the drive components in an effort to get this to work.

BSC inspected the drive and it was found to have extremely worn pulleys. The pulleys were a special type for the machine; new pulleys were machined and supplied. The belt re-supplied was the standard belt previously used and will offer a life of 12 months before replacement.
