# Case Study

## Quick-Flex Coupling

Emba 170 Prefeeder - Cardboard in Feed Conveyor

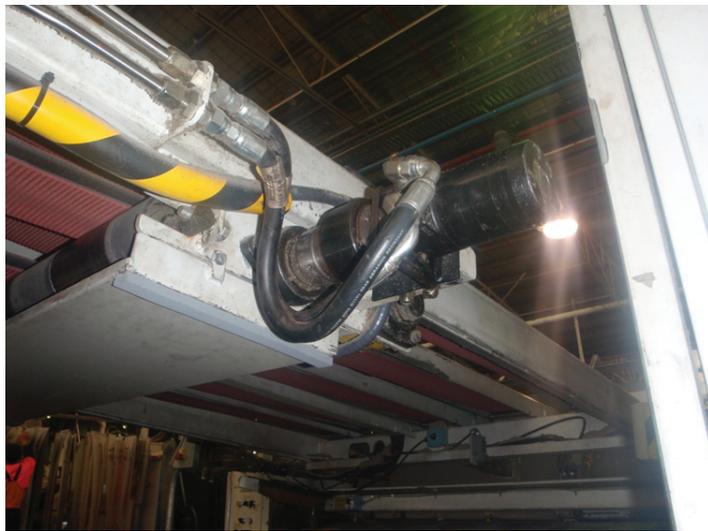
The Original Equipment coupling was failing every 8 weeks, causing unscheduled down time and costly production losses.

BSC redesigned the OE coupling to a Quick-Flex Coupling. The life of the coupling has increased significantly and has now reached 12 months without failure.
