Case Study

Blue Brute Bearings

Bucket Elevator

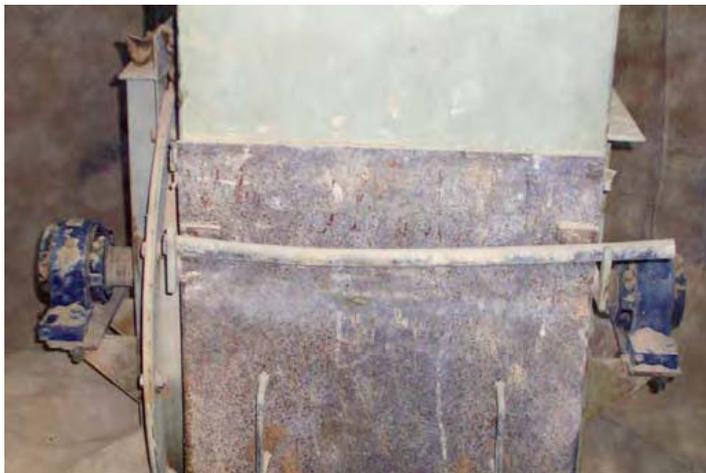
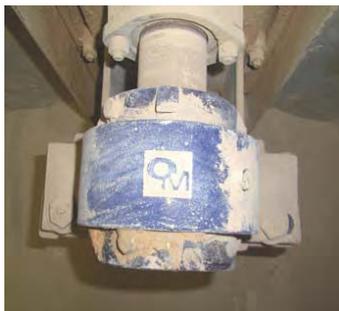
When first asked if the site had any bearing problems, this customer responded: "no, no problems here – we've got everything covered." A store inspection revealed a large number of 100mm bearings in stock. The customers' idea of a bearing 'problem' was all supply & demand related...sure, the site changes out 100mm bearings every week, but it's not a problem as the supplier has heaps on the shelf.

Using TAPN units that were bolt centre and centre height compatible we were able to provide an off-the-shelf replacement with superior sealing and a bearing life expectancy of over 2 years...not days. Adding triple lip snap-on covers 'sealed' the deal and these bearings will now exceed the life of the previous units by a ratio of over 52:1.

At the time of writing this Case Study the Blue Brute bearings had only been operating for 12 months. A significant improvement on every week.
