Case Study

Condition Monitoring

Coal Mine Wash Plant

Main Water Pump

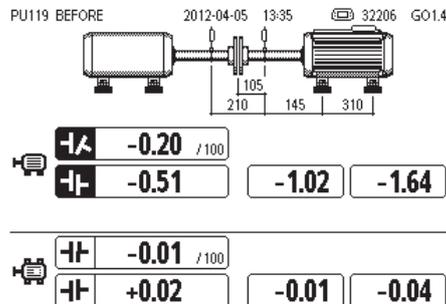
BSC conducts routine condition monitoring for a large coal mine wash plant. On our condition monitoring data collections, our reports indicated vibrations had significantly increased for both motor and pump bearings which warranted serious concern. The main water pump provides water to the plant and should this pump prematurely fail, it would consequently shut the plant.

BSC Engineering Services recommended that the machine be taken out of service for maintenance including an inspection of the coupling and alignment review. After our inspection the analysis report confirmed that the coupling was out of alignment as indicated in the initial reading. BSC laser aligned the shafts to the required tolerance, in accordance with the manufacturer's application specification and rotating speed.
