# Case Study

# Blue Brute Bearing

Conveyor Tail Drum Bearing Assembly

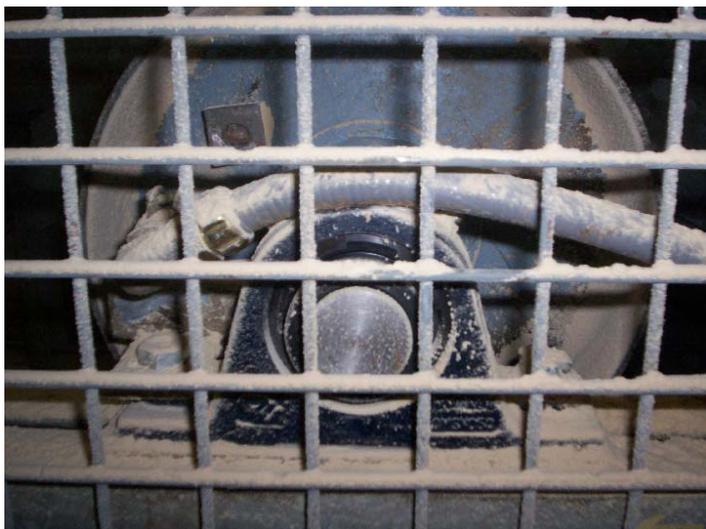
A leading South Australian crushing and waste recycling & processing company were experiencing issues with failed bearings. The main conveyor tail drum bearing assembly was the commonly used 'SN' type arrangement and failing every 3 months due to the ingress of contaminants – the operating environment is particularly harsh. Every 3 months production would stop for 2 hours whilst the failed bearings were replaced, and every 3 months had to purchase new bearing stocks.

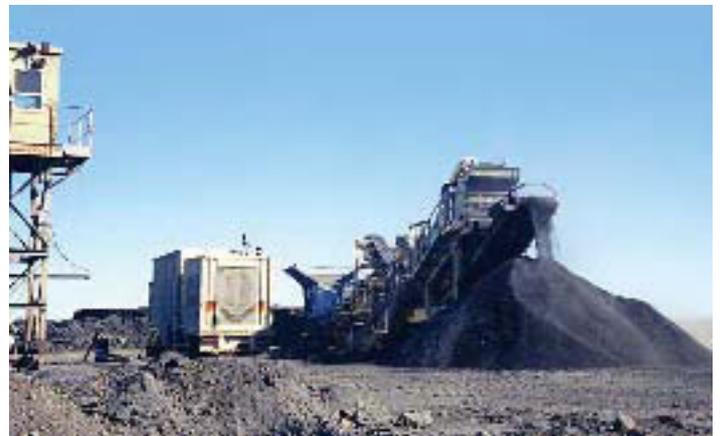
BSC inspected the application and immediately identified this as one requiring the unique combination of a heavy duty unit with superb sealing capabilities. The answer was obvious – the Blue Brute QJMSN15J075S with Triple Lip sealing is designed for these conditions and has the added bonus of the seals running on the inner ring of the bearing (no wear on the tail drum shaft). When change-out is required the Brute's factory pre-set clearance turns a 2 hour job into 20 minutes.

The Blue Brute Bearings have now been in for 8 months, are operating perfectly, and are expected to last over two years. That'll be a minimum 8:1 success ratio.
