Case Study

Split Roller Bearing

Food Processing Plant

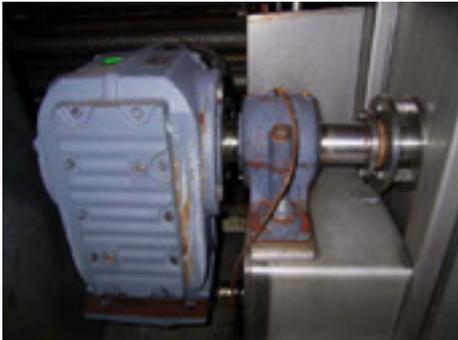
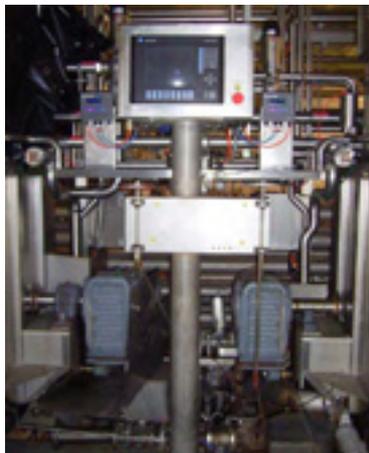
A standard shaft mount gearbox that's trapping a SN520 unit on a Ribbon Blender. Last change out took 2 men, 2 days at 8 hours a day.

Also an issue was the installation of a computer control tower between the drives unable to reach the gearboxes to get to the bearings without cutting the tower in half. The change out time is now estimated at a minimum of 3 days, 10-12 hours a day

Cooper assisted with the fitting of the Cooper Split Roller Bearing and used it as a training session for the fitter.
