Case Study

Carlisle Drive Engineer

Pug Mill

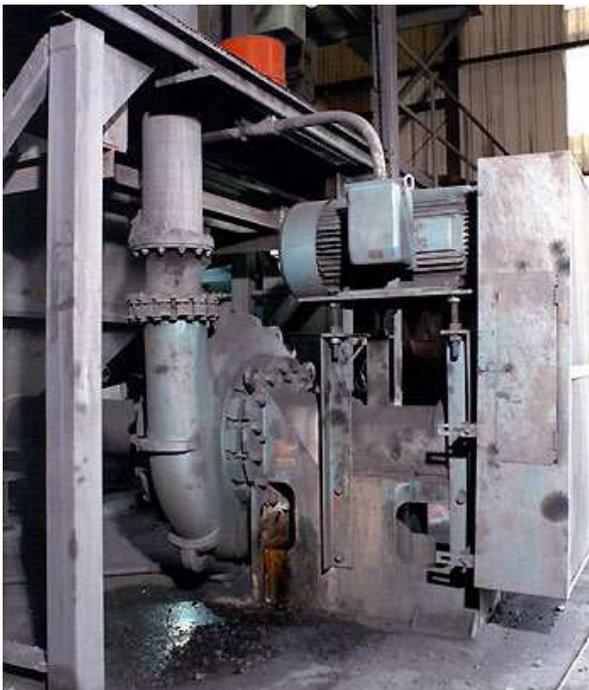
The output of the Pug Mill was falling off and causing issues with plant throughput. The drive had been regularly serviced with new drive gear and monitoring to ensure the best drive results from the gearbox and motor, however continuous stalling was a problem. The weak link was the V belt drive. This was the same specified drive from the original plant, possibly with the original ironware.

The drive was visually inspected by BSC, the pulleys measured and compared to the ISO tolerance gauges, and the main drive information was then taken and entered into the Carlisle Drive Engineer calculation program. The drive was analysed for performance and life expectancy and a proposal for the drive was put subsequently put forward to enhance the life and performance.

Upgrading the drive to the Carlisle Gold Label product and supplying fresh new pulleys would offer this Pug Mill a drive system capable of 3 years continuous life. The change of the drive to this type of Cogged belt would also benefit the site in power consumption reduction and the release of more maintenance time for other important matters around the plant.
