Case Study

Cooper & Blue Brute Bearings

Head Drum

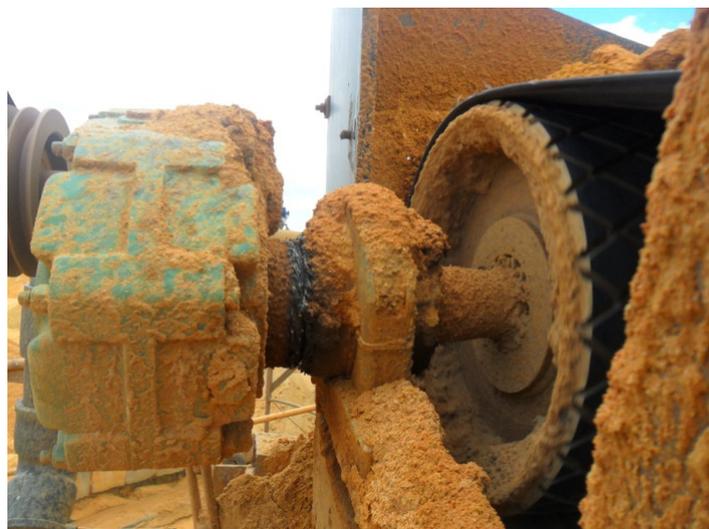
A Sand Quarry in South Australia was experiencing continuous change-outs of the bearing housings as well as the head drum itself as water and sand splashed back from the trammel. The bearings would need to be changed every 6 – 8 weeks and the head drum would need replacement every 8 months as the shaft became worn and corroded.

This application is a common problem for sand quarries throughout Australia and requires a complete bearing solution. BSC redesigned the whole area. First we changed the head drum shaft to a stainless steel shaft and used 2 self locating shaft locking devices welded onto the drum and locked onto the shaft. Utilising Blue Brute and Cooper bearings with advanced sealing technologies solved the issue of water and sand ingress to the bearing units.

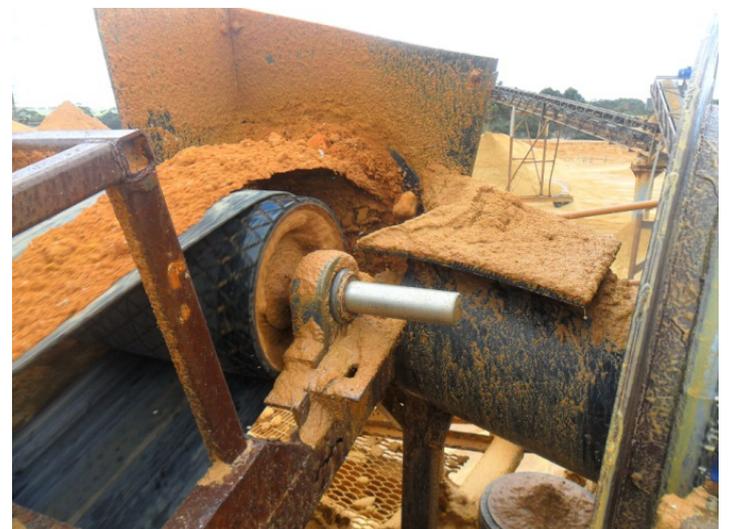
The added benefit of the head drum shaft redesign is that when the shaft needs replacing we can just replace the shaft and save the drum. The original Cooper and Blue Brute bearing units are still in service and performing well – 18 months after installation.
