# Case Study

Timber

Log Deck

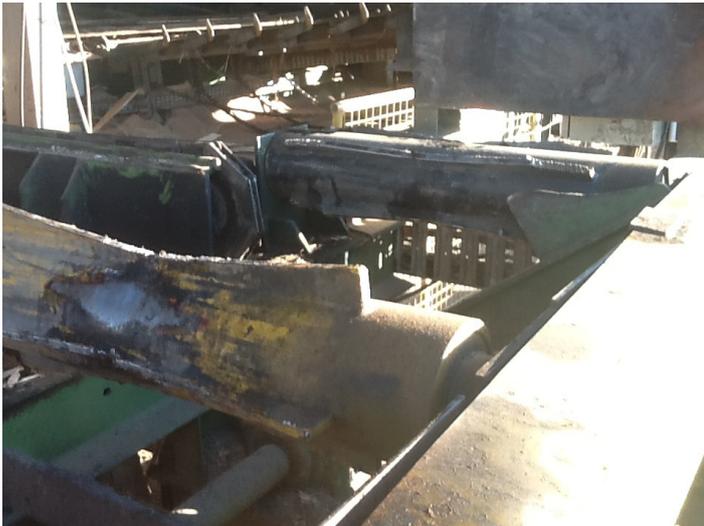
The Timber Mill was experiencing ongoing life problems with the performance of the 16B1 chain on the log deck outfeed rollers. At least once a month the chain would be replaced taking a few hours each time to do, even longer if the sprockets were also showing signs of excessive wear.

BSC recommended Diamond chain be installed. The customer was hesitant at first as the Diamond was at least twice the price of the chain currently used. At the same time the sprockets were changed to BSC's brand.

In the past eight months since making the change the sprockets and chain have not been replaced and on the last inspection still had a long way to go. The customer is very happy with the change to Diamond as it has freed him up to do other jobs which he would not have had time to do. Based on the benefits he is receiving from Diamond chain the customer is now reviewing his brand of bearings looking for quality products with longer life.
