Case Study

NSD-X3 Stainless Coating

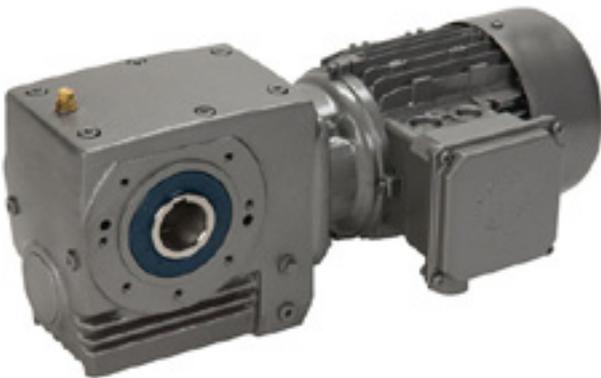
BSC proposed the NORD SK12063 helical worm geared motor with 35mm Gripmaxx® taper grip hollow shaft coated in NSD-X3, NORD Severe Duty Extreme, coating.

The NSD-X3 coating is a polyurethane resin impregnated with 316 stainless steel applied with an etch primer and a clear top coat.

The NSD-X3 coating provides improved protection in corrosive environments (salty, acid, or caustic) with no degradation in coating quality even after a 6 month soaking test in 3% salt water. The NSD-X3 is also chip-resistant with increase hardness of the coating due to the stainless steel.
