# Case Study

## Diamond 400 Chain

Packaging Machine

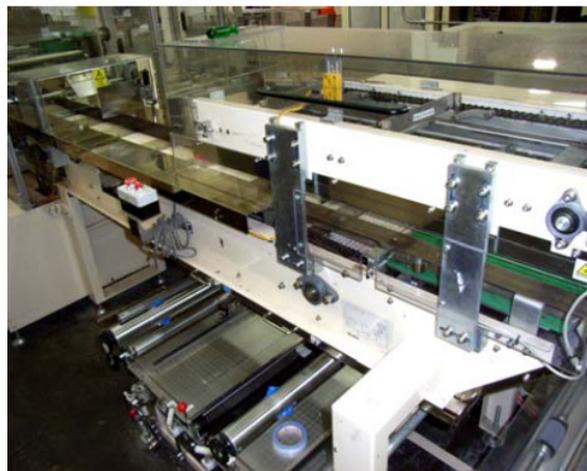
Bulk Plastic wrap, into 5 and 10 packs. The 2 x Slow - Medium speed machines package most of the Australia demand. Existing Japanese origin chains had little adjustment and therefore required replacement every 6 months.

BSC inspected the application and found that the existing 40-1, hollow pin chain in a Japanese quality, was rated at HALF the allowable load of Diamond standard solid pin chain. We replaced the existing chain with Diamond extended pin chain, modifying the plastic conveyor roller to suit the extended pin. Tolerance matched, pre-loaded chains with 50% more allowable load coupled with Diamond quality has extended the chain life x at least 400%.
