# Case Study

# Magna Crete 9555LOC

Culvert passing under roadway and flood control gate

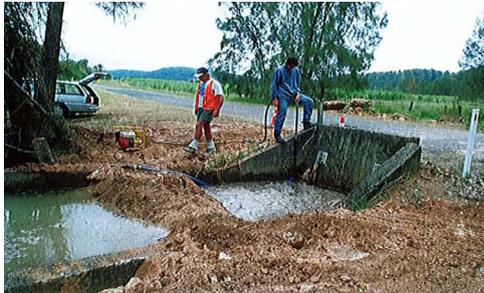
The Culvert had developed erosion around the valve door and leakage had reached unacceptable levels. Traditional repair methods would require road closure and demolition of culvert, replacement, road repair and resurfacing. The cost of job would be 8 weeks down time and \$98,000, this was not viable for Council Budget.

Loctite Magna Crete is a superior two part rapid setting concrete repair and grouting system. The product once applied has 1% porosity and will not shrink or crack. These properties allow the repairs to take place utilising the existing culvert and without disruption to the road surface or traffic. Repair time was 5 days at a total cost of \$14,790
